(Inventory Number VA05910) Potomac River Basin

4. TITLE (and Subtitle) Phase I Inspection Report National Dam Safety Program, Lake Fairfax Dam Fairfax County, Seawater Virginia		5. TYPE OF REPORT & PERIOD COVERED Final rept.

NAME OF DAM: LAKE FAIRFAX DAM

PHASE I INSPECTION REPORT
NATIONAL DAM SAFETY PROGRAM
NAME OF DAM: LAKE FAIRFAX DAM ID# VA 05910

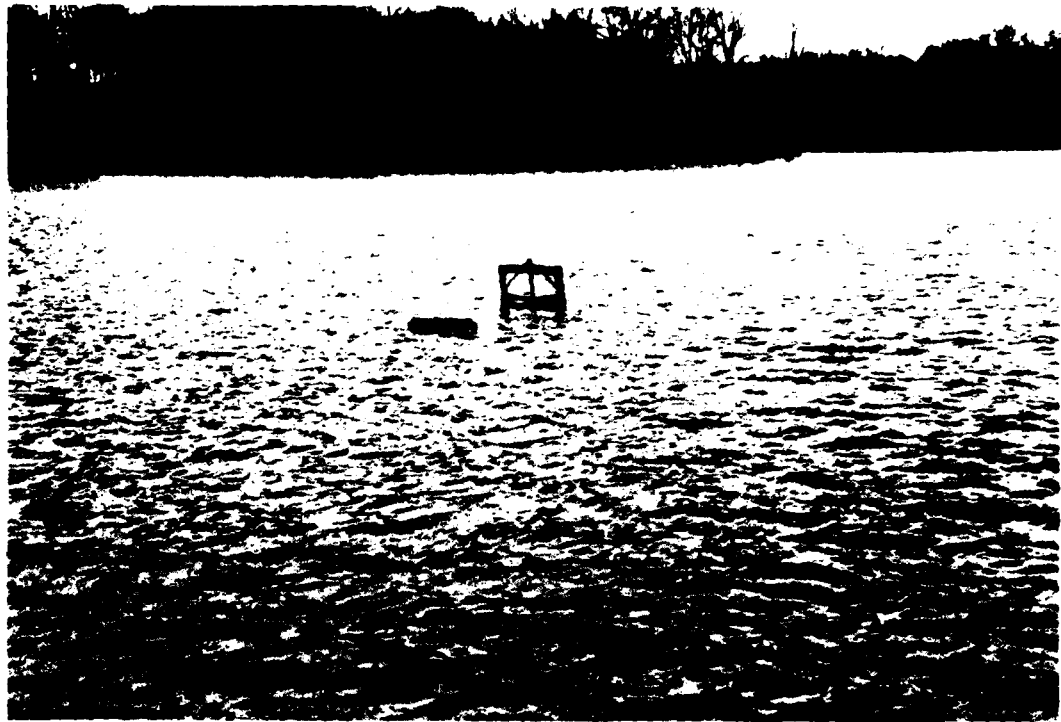
There is an emergency gate, but there is no information available on the size or type of gate. The gate is controlled by a stem which rises above normal pool just upstream of the principal spillway intake. The controls for the gate appear to be in poor condition; according to the owner, the gate is no longer operable.

PHOTO 1. Principal Spillway Intake and Controls for Emergency Gate

- 8) The emergency gate should be repaired and maintained in an operable condition.

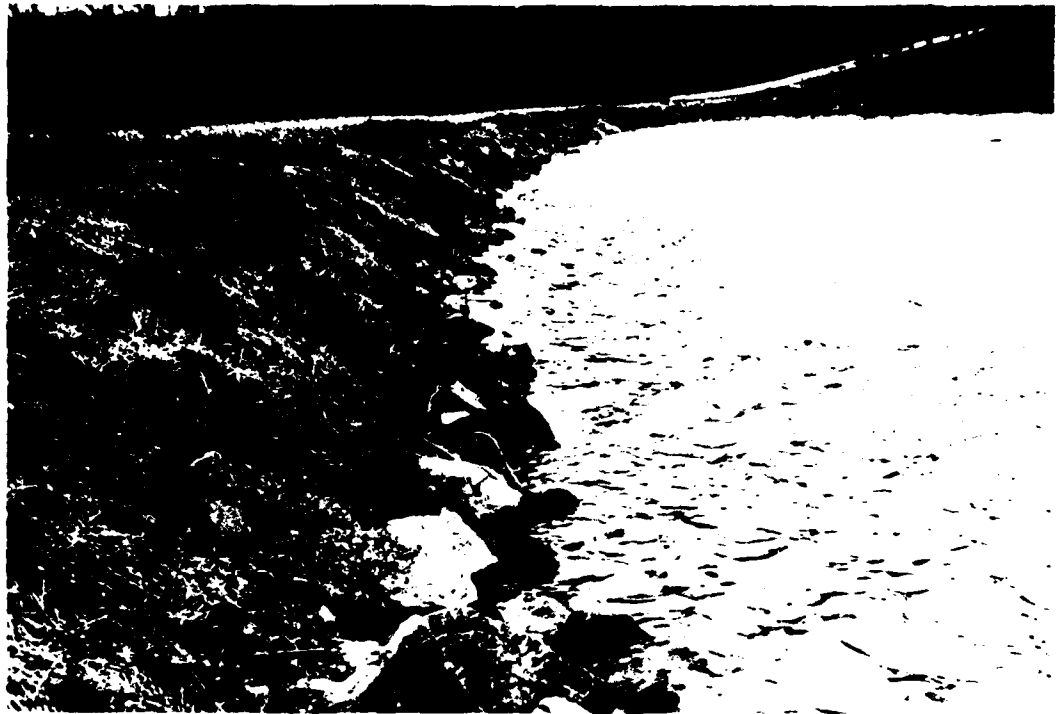
Dam: The embankment was found to be in generally fair condition with no surface cracks or sloughs. There is almost no grass on the steep, moderately eroded upstream slope. The left side of the downstream slope has a fairly good cover of grass, but there are scattered traces of erosion in this area. The right side of the downstream slope is slightly uneven; grass cover is sparse and scattered, and moderate erosion has taken place in bare areas. A shallow erosion gully has formed on the lower portion of the downstream slope approximately 100 feet from the right abutment. There is an erosion gully at the outlet of a 12 inch concrete pipe in the right downstream abutment. The pipe apparently drains the right downstream hillside. The outlet section of the pipe has broken off due to erosion of the soil support. Riprap has been placed on the upstream slope. It is partially covered by soil in the upper portions. There are no apparent failures but the slope is uneven in some areas. The stone is hard and angular and ranges in diameter from 1 foot to 2 feet. The stone does not cover the entire slope on the left side of the embankment adjacent to the right training wall of the emergency spillway approach channel. The unprotected slope in this area is very steep; the embankment has apparently eroded away from behind the training wall.

PHOTO 3. Upstream Slope from Left Side of Dam

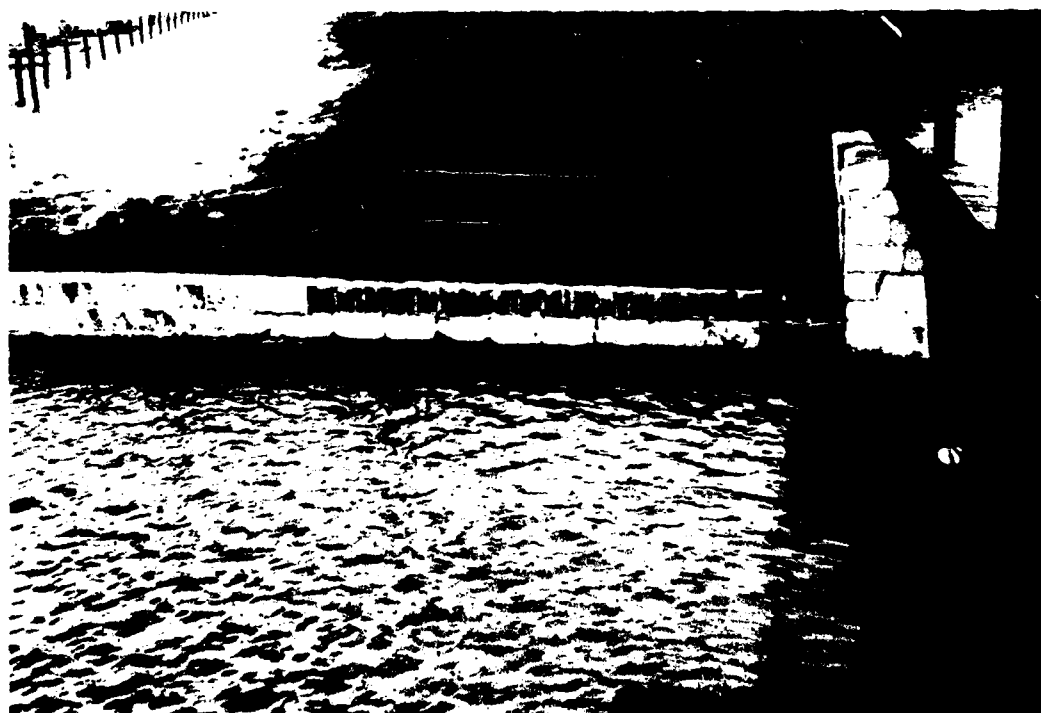
Appurtenant Structures: The top row of cinder blocks on the left training wall of the emergency spillway approach channel is crumbling. The ogee weir in the emergency spillway appears to be in good condition. There are four medium-size logs caught on or just upstream of the weir. There are some cracks in the cinder block training walls of the rectangular portion of the discharge channel. There are a few logs caught on the energy dissipators in the roughly shaped concrete chute portion of the discharge channel. There is a hole approximately 8 inches in diameter in the concrete near the left edge of the chute just downstream of the road and there are cracks and some erosion around the edges of the chute. There is a large void under the chute at its downstream end; a surveyor's rod was pushed into this void to a depth of 11 feet. Both bridges and the road across the emergency spillway appear to be in good condition.

PHOTO 6. Crumbling Cinder Blocks on Left Training Wall of Emergency Spillway Approach Channel

- 4) The crumbling cinder blocks on the left training wall of the emergency spillway approach channel should be replaced.
- 5) The cracks in the cinder block training walls of the rectangular portion of the discharge channel should be patched.

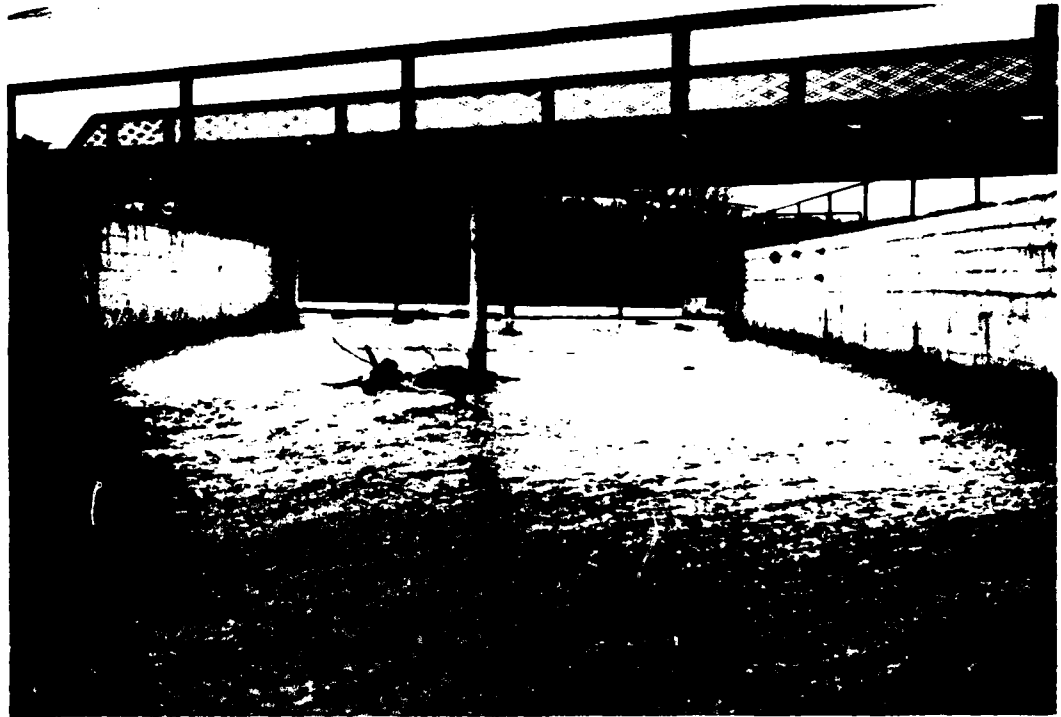
**PHOTO 7. Upstream Portion of Emergency Spillway from Asphalt Road
across Emergency Spillway**

- 6) The logs caught in the emergency spillway should be removed.
- 7) The hole in the concrete chute just downstream of the road should be repaired; the large void under the downstream end of the chute should be filled.

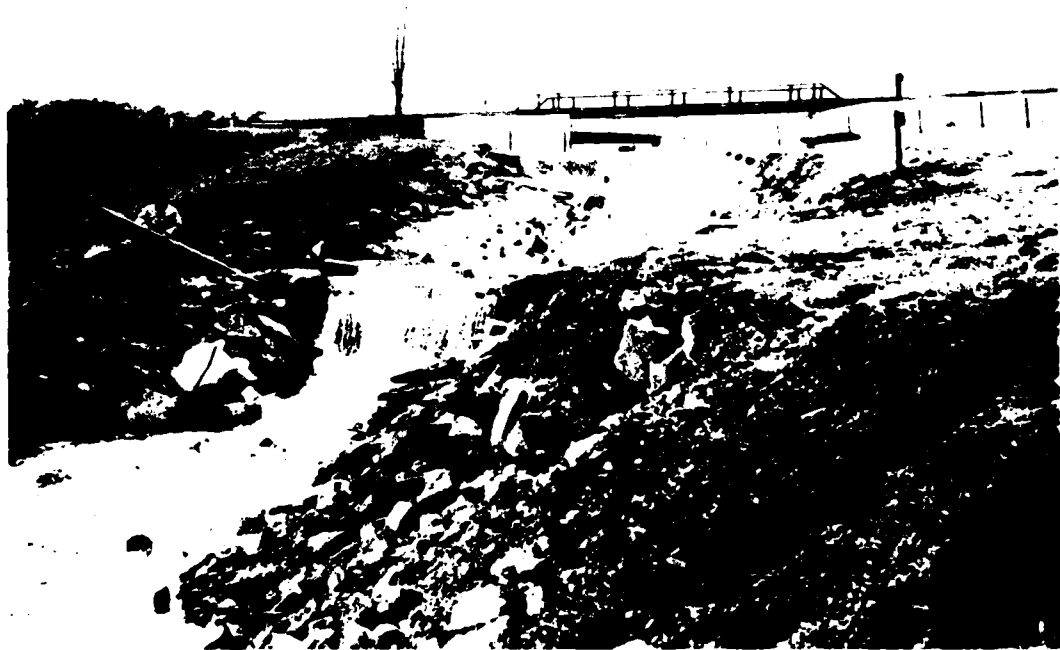
PHOTO 8. Downstream Portion of Emergency Spillway

VISUAL EXAMINATION OF	OBSERVATIONS	REMARKS OR RECOMMENDATIONS
DISCHARGE CHANNEL (continued)	<p>downstream of the road and there are cracks and some erosion around the edges of the concrete. There is a large void under the chute at its downstream end; a surveyor's rod was pushed into this void to a depth of 11 ft. The sides of the chute are protected with riprap and broken concrete slabs. The chute discharges into a riprapped channel which joins the original streambed after approximately 200 ft.</p>	<p>If it became clogged with debris, the chain-link fence would restrict flows.</p>
BRIDGE AND PIERS	<p>There are two bridges across the rectangular portion of the discharge channel: a footbridge which crosses at a right angle approximately 20 ft. downstream of the weir and a bridge for the narrow gage railroad, crossing at a skew near the downstream end of the rectangular channel. There is a chain-link fence suspended from the upstream side of the footbridge. The railroad bridge has 2 piers of 5 in. C.I.P. near the center of the channel. Both bridges appear to be in good condition.</p>
